Pre-anesthesia Check of Breathing Circuit - Is it infallible?

Abstract:

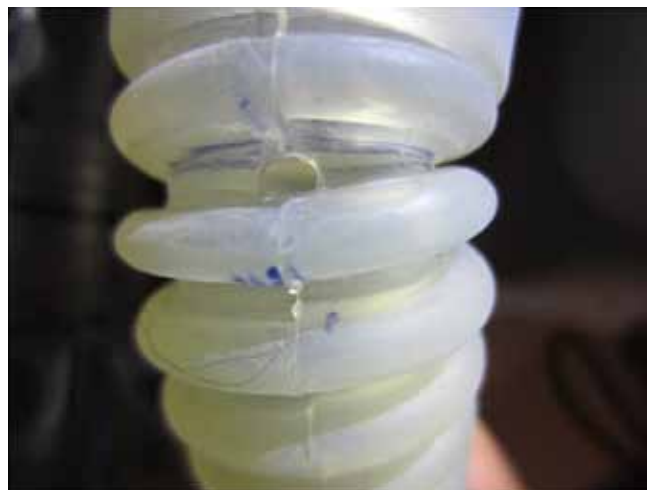
was reversed and extubated uneventfully. Later, on examining the defective breathing tube, a rent 2.5 mm in diameter was identified in the expiratory limb of the breathing circuit [Fig.1].

Fig.1: Rent in the circuit that got revealed on extending the corrugations.

The tear was also not evident on casual inspection of the tube but only on stretching the circuit as the tear was present in between the corrugations. The ground facing location of the puncture and the hanging down position of the circuit were responsible for close approximation of the edges of the opening. This had enabled the leak test to be passed both the times. Possibly during the whole period of anesthesia for first case and the beginning of the second case the hole was sealed in between the corrugations. Later on when the pre-use check was repeated with the defect in other positions like at the patient end or facing superiorly, the leak was at once detected as now the corrugations were brought apart. Stretching or lifting of the circuit during mechanical ventilation in the second patient had caused the leak to be evident as this had brought corrugations apart [6]. The learning from the above episode is that any incident which howsoever may seem to be a trivial one should encourage an accident investigation, reasoning, rectification and formulation of policies for prevention of any such untoward event. First of all, as mentioned the surface of the anaesthesia workstation should not be used to store objects as blade, needles, syringes which might be a detriment for the anesthesia equipment. The technical staff should be sensitised to the significance of careful handling during disinfection, sterilisation, storage and usage of anaesthetic equipment to avoid physical or caustic injury to these valuable equipment. We also suggest that not only the breathing circuit be inspected to determine for damaged or missing parts, presence of foreign bodies [7]; we should routinely extend the tubing to

its full length prior to the checkout so that the leak within the corrugations can be picked [6].

This incident highlights that standard maintenance; complete pre-use check and previous uneventful use do not give surety against intra-operative machine error. It stresses the importance of eternal vigilance, speedy and methodical assessment of breathing system disconnects and the availability of alternate O₂ source and manual resuscitator so that the primary event does not progress to the point of patient injury. We also stress that the pre-anaesthesia check guidelines for checking leak in the breathing circuit to be further specific in emphasising the need for stretching the breathing circuit to be used to be stretched to the full length while testing so that the leak within the corrugations can be picked [10,11]. The present guidelines are silent on this [4].
