# Accidental Cannulation of Left Superior Intercostal Vein: A Rare Instance of Central Venous Catheter Malpositioning

Srinath Shankar Rathod<sup>1</sup>, Gopal Sharma<sup>2</sup>

<sup>1</sup>Department of General Surgery, Shalby Hospital, Mohali, Punjab; <sup>2</sup>Department of General Surgery, University College of Medical Sciences & Guru Teg Bahadur Hospital, Delhi, India.

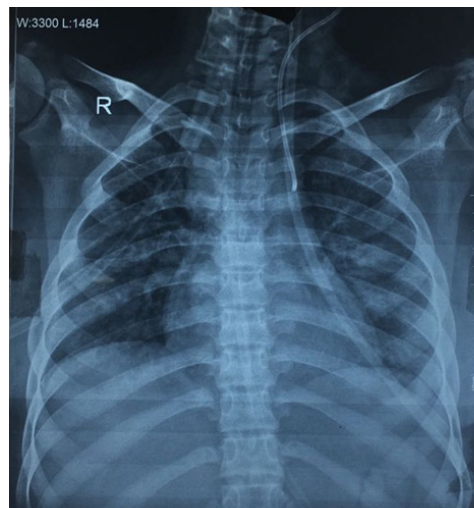
**Fig.1:** Postero-anterior chest X-ray depicting CVC in left IJV immediate post-insertion.

A 22-year-old female, known case of disseminated tuberculosis was referred from a local hospital to our center. There she underwent exploratory laparotomy for perforation of the second part of the duodenum and was referred to our center with shock and bilious discharge from the main wound. She already had right internal jugular vein (IJV) CVC that had to be removed due to infection of the catheter. Thus, the decision to place CVC in internal jugular vein (IJV) on the left side was made and written informed consent from patient's relatives was taken. After thorough aseptic precautions and using ultrasound guidance CVC was placed in left IJV vein. Check radiographs [Fig.1] post-CVC placement showed that the left sided IJV was cannulated and CVC was in situ with good back flow and smooth forward flow of fluids except in the distal port. However, next day poor backflow raised the suspicion of malposition of the catheter. The diagnostic confusion regarding malposition

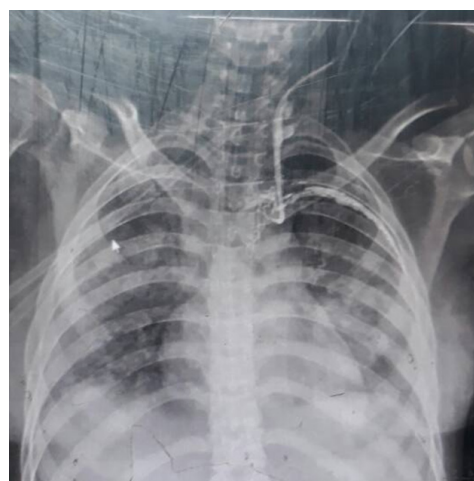
**Fig.2:** Postero-anterior chest X-ray shows opacification of left superior intercostal vein on contrast injection through CVC.

of the catheter was resolved after contrast dye injection through the CVC which showed [Fig.2] that the catheter had traversed the left superior intercostal vein. The CVC was repositioned and no complication occurred related to CVC.

On upright postero-anterior chest radiograph, the left superior intercostal vein can be identified in 1.4%-9.5% of healthy people as a small “nipple” lateral to the aortic arch [4]. On plain x-ray of chest dilated left superior intercostals vein could be difficult to differentiate from an aortic aneurysm and enlarged lymph node [4]. In the presence of persistent left superior vena cava (SVC), left superior intercostals vein drains into it. The position of the CVC in the left superior

intercostal vein can be distinguished on chest x-ray from that of the catheter in a persistent left superior vena cava, as the latter descend along left side of the mediastinum without arching laterally over aortic arch [4].
